**DEPARTMENT OF TRANSPORTATION**

Contract #: 04-0120F4Cty: SF/ALA Rte: 80 PM: 13.2/13.9File #: 13.28**WELDING INSPECTION REPORT****Resident Engineer:**Pursell, Gary**Address:** 333 Burma Road**City:** Oakland, CA 94607**Report No:** WIR-005409**Date Inspected:** 13-Feb-2009**Project Name:** SAS Superstructure**OSM Arrival Time:** 630**Prime Contractor:** American Bridge/Fluor Enterprises, a JV**OSM Departure Time:** 1700**Contractor:** Oregon Iron Works Clackamas, Or.**Location:** Clackamas, Oregon**CWI Name:** See below**CWI Present:** Yes No**Inspected CWI report:** Yes No N/A**Rod Oven in Use:** Yes No N/A**Electrode to specification:** Yes No N/A**Weld Procedures Followed:** Yes No N/A**Qualified Welders:** Yes No N/A**Verified Joint Fit-up:** Yes No N/A**Approved Drawings:** Yes No N/A**Approved WPS:** Yes No N/A**Delayed / Cancelled:** Yes No N/A**Bridge No:** 34-0006**Component:** Hinge K Pipe Beams**Summary of Items Observed:**

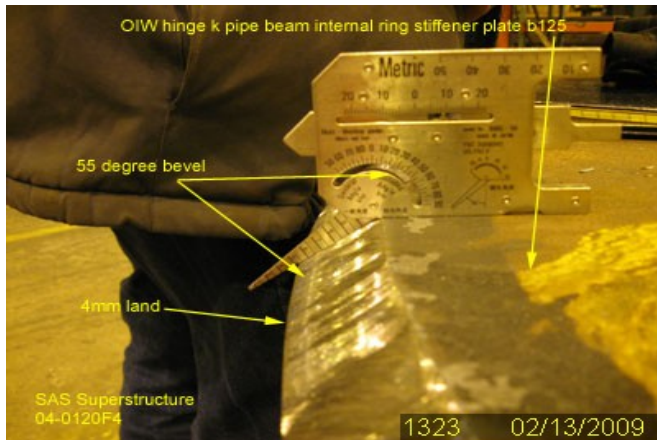
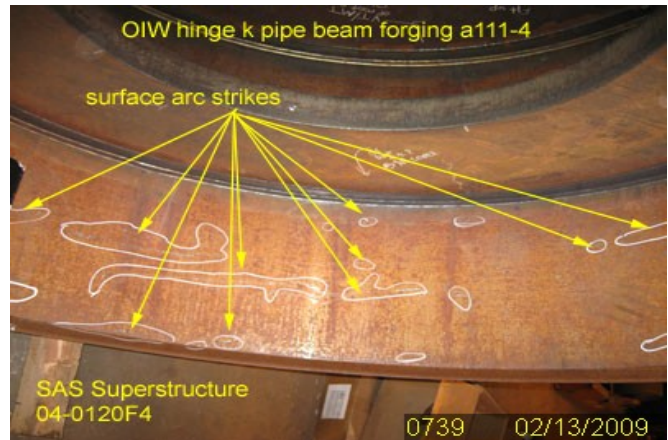
The following digital photograph below illustrates observation of the activities being performed.
